"Full" Reserve Study

Spring Creek Ranch Harvest Dance Jackson, WY

Report #: 36151-0
For Period Beginning: January 1, 2019
Expires: December 31, 2019

Date Prepared: February 7, 2019

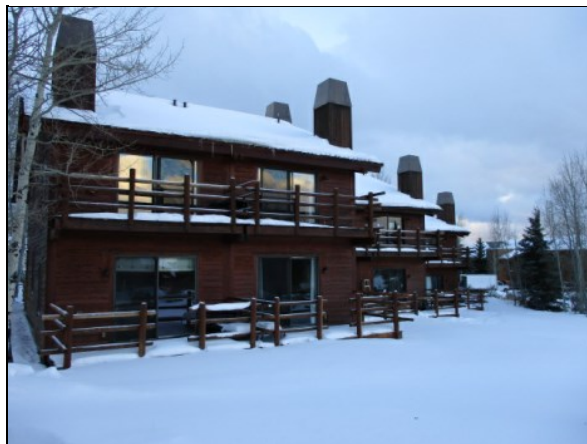
Comments: Contact reported that the decks are original to the property and have not been replaced. A Reserve Study does not include forensic or structural testing of the decking systems. Based upon the current age of the decking system we recommend that the client expect the need to resurface the decks. Plan for large scale repair / replacement at roughly the interval below. As routine maintenance inspect deck stairs and railings annually and repair as needed. As part of maintenance apply water repellent stain/preservative at least every other year. Options for a longer lasting deck include such things as using a thick wood boards of suitable species or a composite product. Composite materials are available that require less maintenance and lower life cycle costs typically. Funding for replacing existing wood boards with in-kind material is factored below. Costs can increase greatly if decay of the structural framing is found.

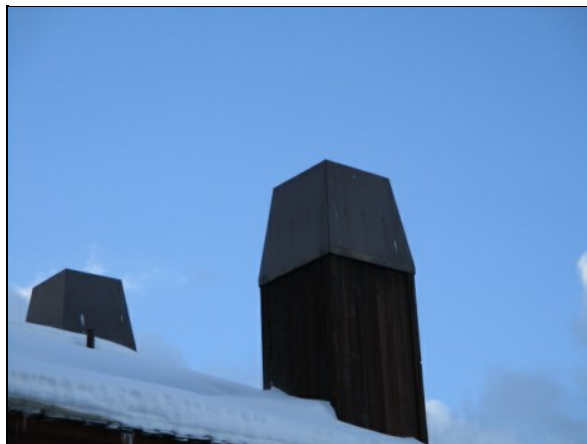
Comments: Chimney components should be scheduled for replacement at the approximate interval shown below. Best practice is often to coordinate replacement with the roof itself. Should be inspected maintained and repaired periodically to ensure good function. Extra attention should be paid to moving parts such as hinges and latches to ensure safety and functionality. Inspect periodically for leaks around frame and repair as needed.
