SPRING CREEK RANCH

AMANGANI

**Wildfire Defense Master Plan  
and  
Emergency Procedures Manual**

**Developed by  
Y2 Consultants, LLC  
2021**

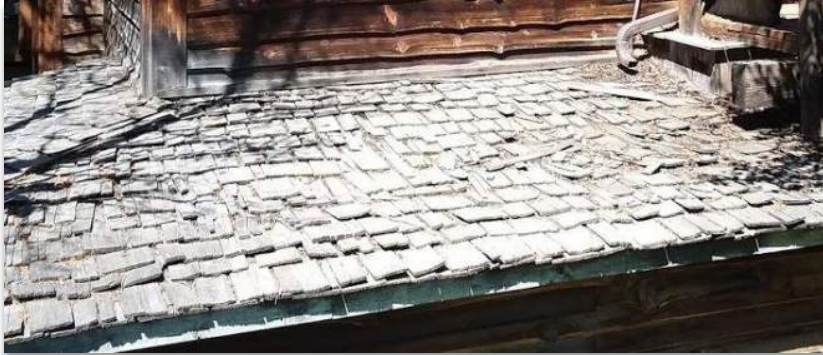
Figure 1. Cedar shake roof in disrepair. Note litter (needles and leaves) collected on the right side of the photo.

While some of the shake roofs are in good condition, many have missing,

loose, or cupped shingles. Some have an accumulation of leaf litter and need cleaning and repair (Figure 1).

It is critical to regularly inspect and clean out any areas where debris can accumulate. Annual inspection is recommended as a minimum.

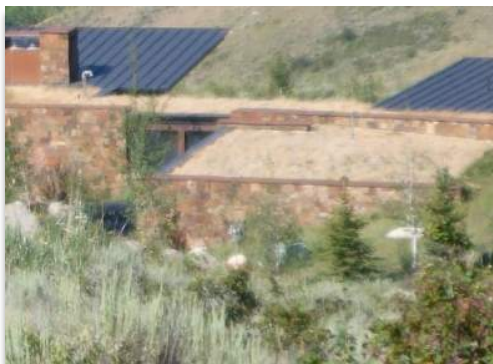
Some homeowners have installed green roofs. If kept irrigated and are green, these roofs have a low potential for ignition by embers. However, some green roofs are not being maintained and represent a significant ignition potential to the home (Figure 2). Green roofs should be irrigated and have dead vegetation removed on a regular basis to maintain fire safety. Green roof vegetation should not be in contact with any flammable surface such as wood siding, eaves or roof overhangs. The Homes at Amangani Supplementary Design Guidelines (June 2000) allow flat sod roofs with irrigation; these are appropriate if vegetation is kept irrigated and away from wood siding on multi-level roofs.

Figure 2. Green roof in need of maintenance or repair.

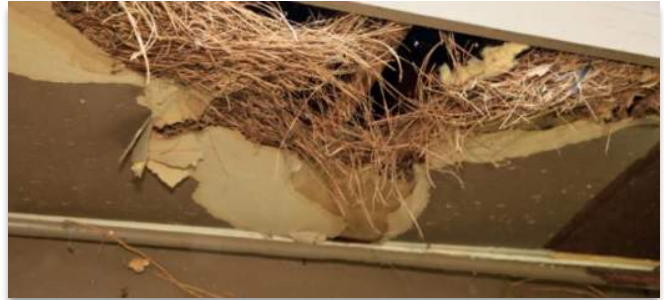
Figure 3. Bird nest under eaves.

Eaves should all be tightly boxed in, even on decks, and maintained. Soffit vents, attic vents and cold roof vents should be covered with 1/8-inch non-corrosive metal screen.

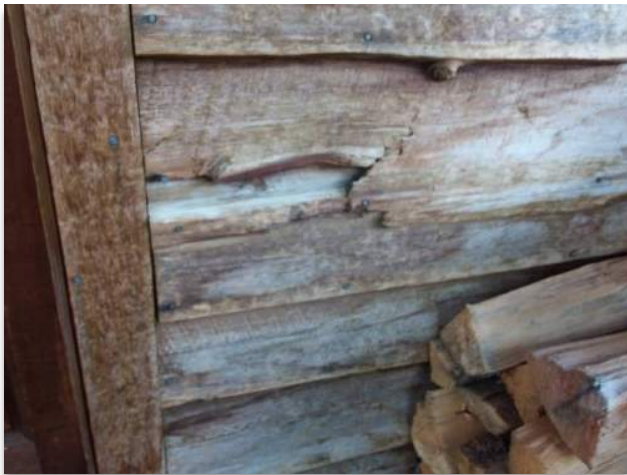
Figure 4. Wood siding in poor condition with firewood stacked against the siding.

Y2 observed many woodpiles in contact with the structures and on or under wooden decks (Figure 4). This is an extremely dangerous practice. Woodpiles should not be stored within 30 feet of any building. Y2 observed improper disposal of partially burned firewood and hot ashes into unsafe bins. We recommend a policy be enacted by SCHOA for rental units that only trained

Wood siding is not recommended. If wood siding is selected it should be tight and/or beveled to avoid collecting embers. Siding must be regularly maintained to avoid areas of separation and animal damage where embers could enter and ignite (Figure 4). If used, wood siding should not be in contact with any vegetation and preferably at least three times the height above adjacent vegetation. Any area of wood siding where embers could land and accumulate should have metal flashing. Full logs offer more fire resistance over wood siding if wood is preferred. Any gaps in siding or logs should be caulked or chinked annually. We recommend an ignition resistant or non-combustible siding be selected instead of wood when remodeling, retrofitting, or modifying.

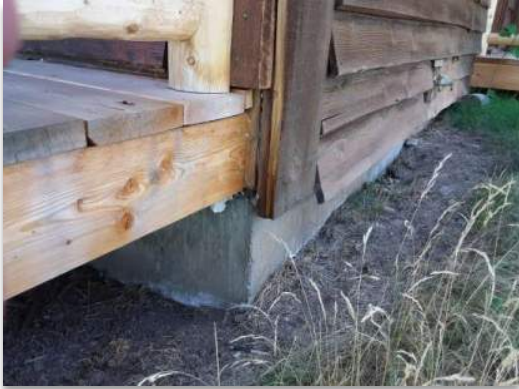
Figure 5. Concrete foundation where siding deteriorated, allowing debris to accumulate and where embers could blow in. The deck should be screened to prevent buildup of flammable materials.

Foundations and the connections between the foundation and siding can be made fire-resistant. Most of the foundations observed in SCR are concrete, which is non-combustible. Any vents into crawlspaces should be screened as described above. Siding should be inspected for gaps above the foundation (Figure 5) potentially caused by snow, sprinklers, or age.

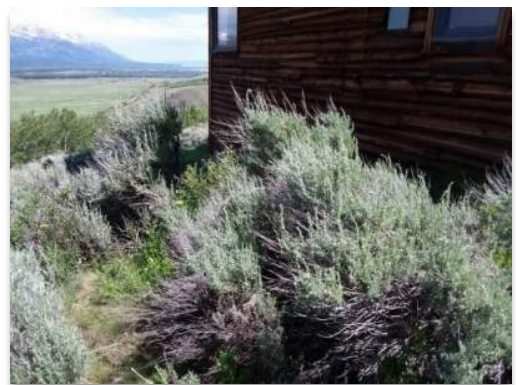
In some cases, unirrigated native vegetation encroaches up to the structure (Figure 6). This, compounded by steep slopes, puts these structures at high risk. Best practice is to have either no vegetation in the 0-5 feet zone, or to have irrigated, mowed lawn. Under no circumstance should the landscaping touch the combustible siding

Figure 6. Highly flammable native vegetation touching wood siding.

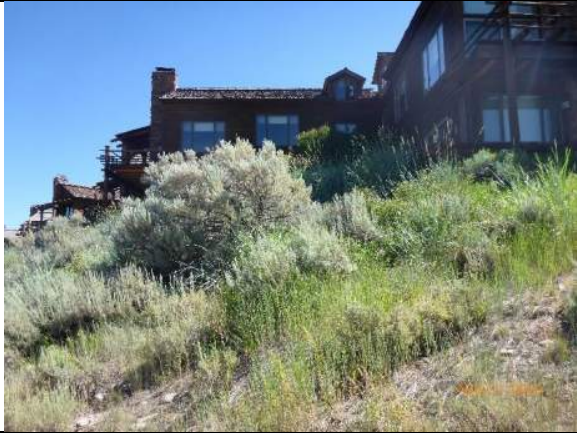
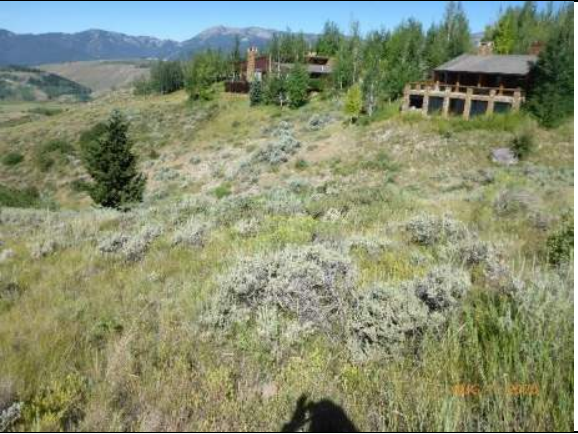
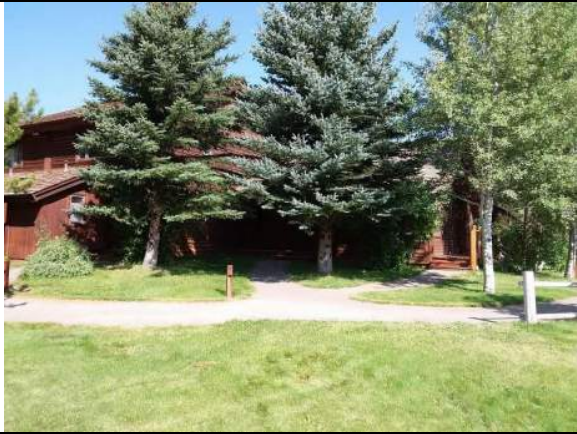
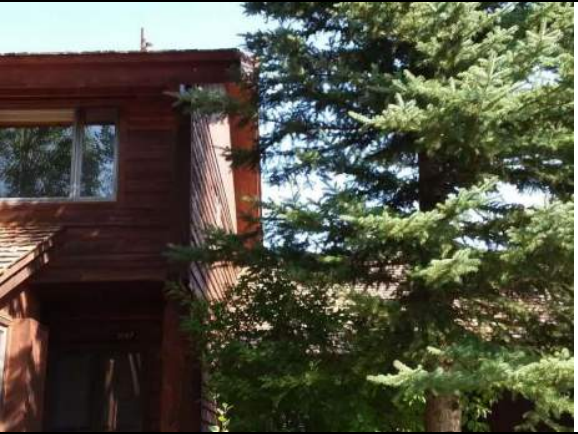
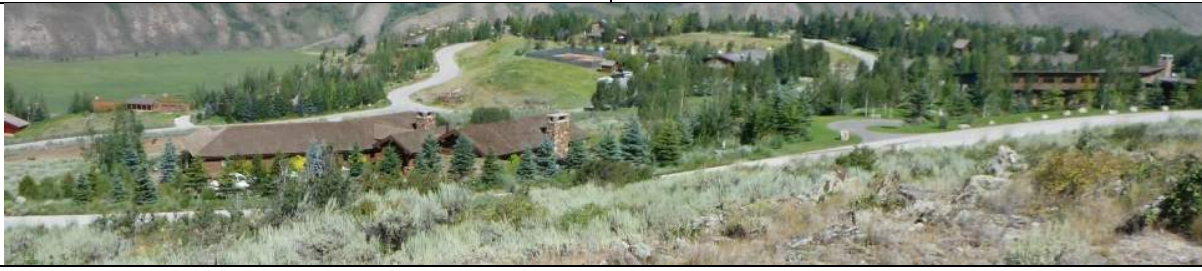
Figure 8. Examples of landscaping not meeting Firewise guidelines.

<p>Example of slope and native vegetation encroachment next to structure.</p>	<p>Example of slope and native vegetation encroachment next to structure.</p>

<p>Conifers, though limbed up, are too close together and too close to structure in the Immediate Zone.</p>	<p>Limbed up conifer almost touching the structure.</p>

<p>Most of these conifers are in the 30 to 60-foot zone, are too close together, and are not limbed up.</p>

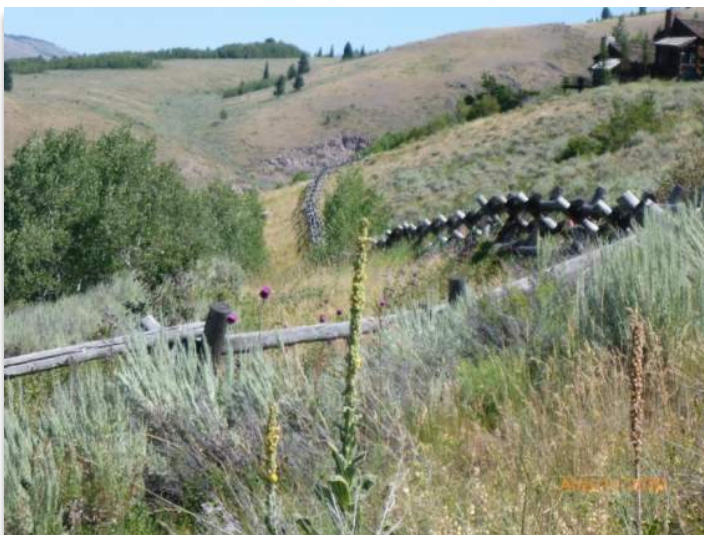
Figure 1. Greenstrip 1 looking north, August 2020

The 2007 plan was designed to create a loop of greenstrips around the SCR open space with an emphasis on the west (Figure 1) and southwest boundaries due to prevailing wind direction and increased ignition sources. Four greenstrips of varying widths were proposed on the property (Figure 2). Initial recommendations to the SCHOA included significantly wider greenstrip widths than were ultimately approved and anticipated some additional fuels mitigation work would be completed on private parcels adjoining the greenstrips. Below is a summary of the status of the approved widths for each open space greenstrip since 2007.

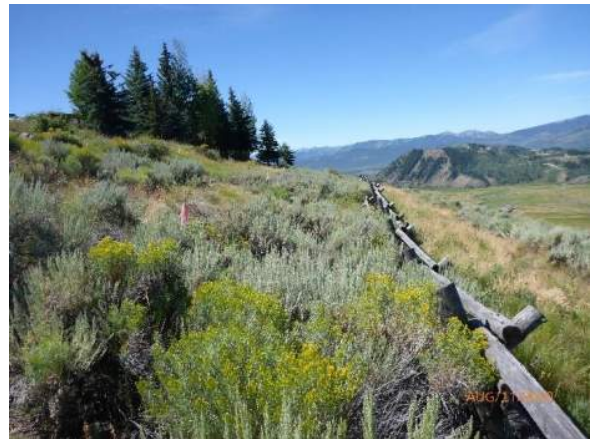
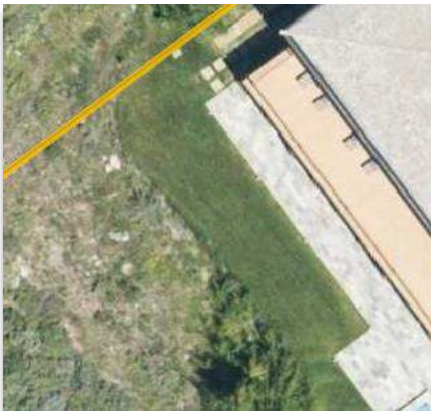
Figure 5. Irrigated lawn between the greenstrip and the residence.

If sagebrush cannot be replaced with short stature native grass between the greenstrip and the residences, we recommend removing the sagebrush and installing irrigated lawn as far out from the structure as possible on the south and west face of the homes (Figure 5).

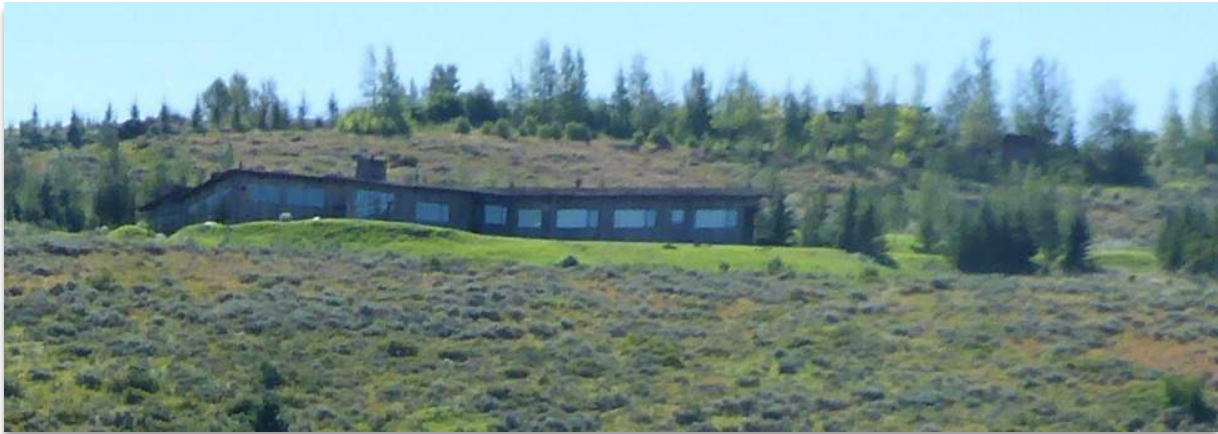
Figure 7. Example of a structure upslope from moderate fuels with a well-established and maintained greenstrip adjacent to a home.

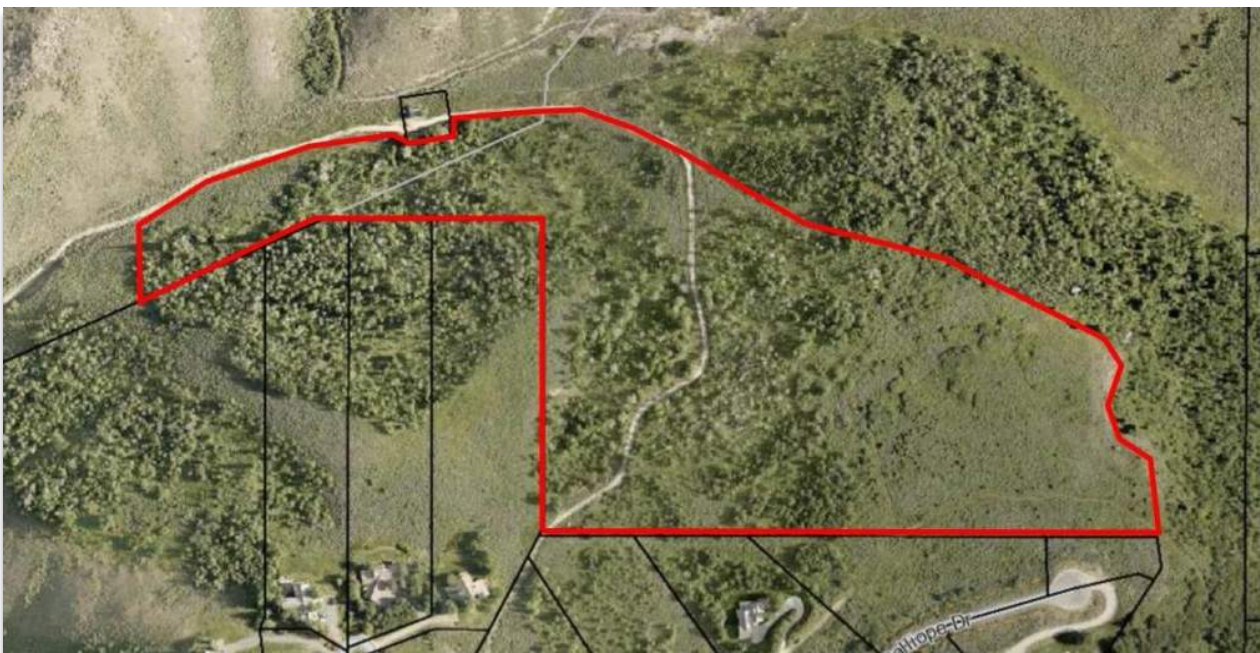
Since 2007, some dead and downed wood has been removed on the south and west side of the utility road. Given the current condition of the road and based on recommendations from Fire/EMS, the idea of improving the two-track is being abandoned. Instead, efforts should focus on fuel reduction within the area identified in Figure 8.

Figure 8. Treatment area associated with greenstrip 2.

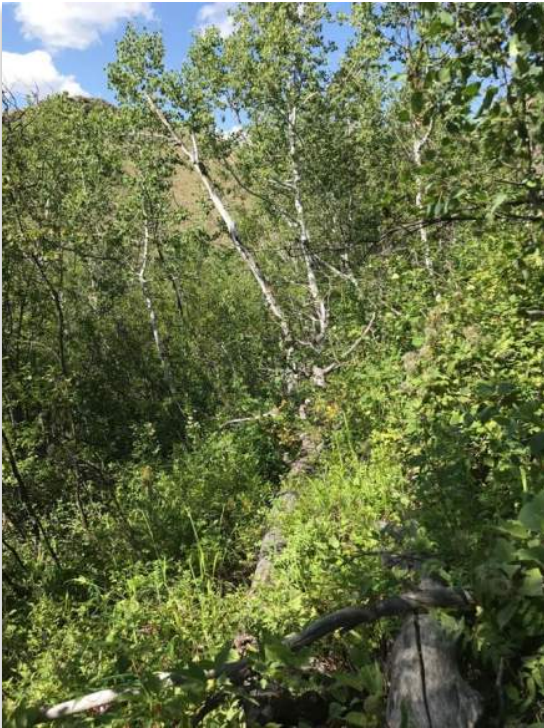
Figure 9. Undergrowth and deadwood adjacent to the utility road.

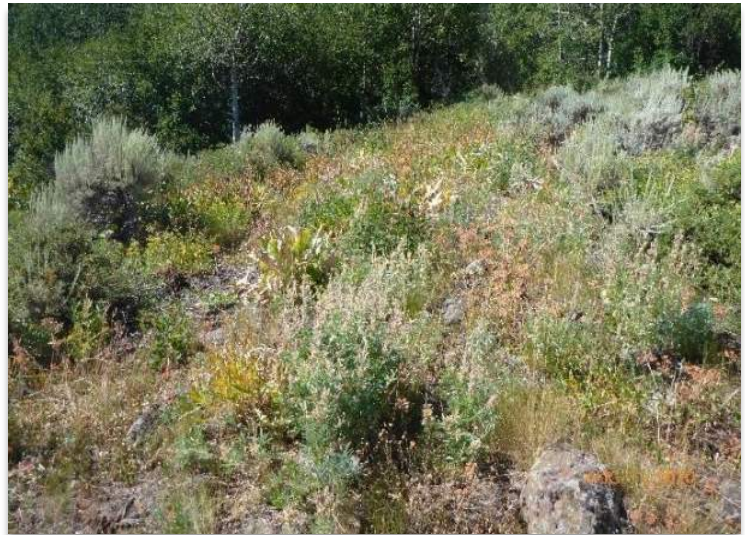
Figure 10. North end of greenstrip 3 where it joins greenstrip 2.

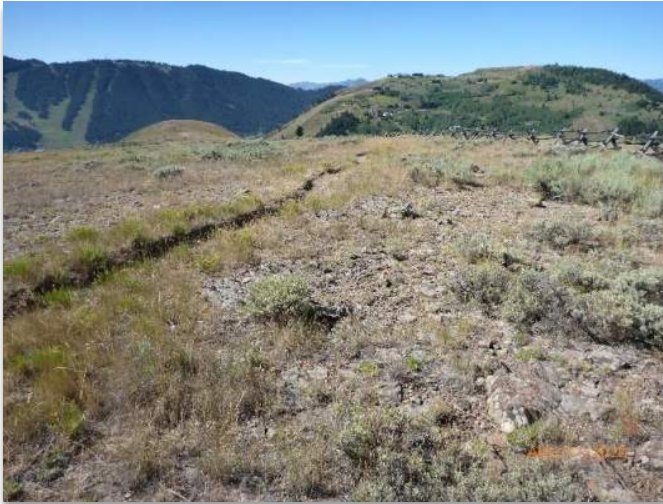
Figure 11. Greenstrip 3 C.

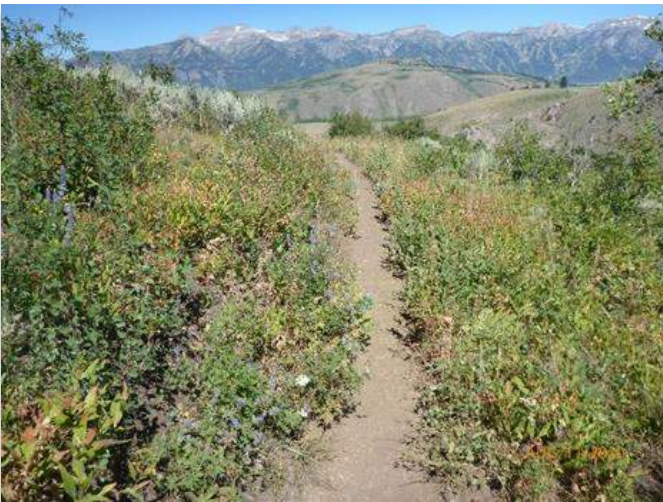
Figure 12. Horse trail going into the aspens on the north side of the butte from greenstrip 3A to 2.

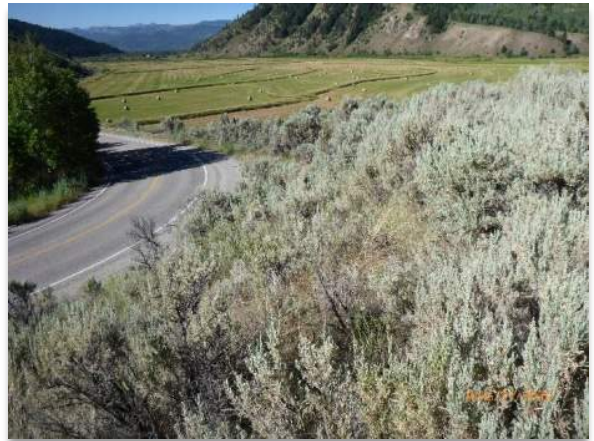
Figure 13. Sagebrush adjacent to N. East Butte Road.

We recommend mowing the downhill portions and the portions of the roads with taller grass and sagebrush back to 10 feet where possible. Areas with aspen should have the understory cut back to at least 10 feet. Aspen do not need removed but any encroaching conifers should be removed.

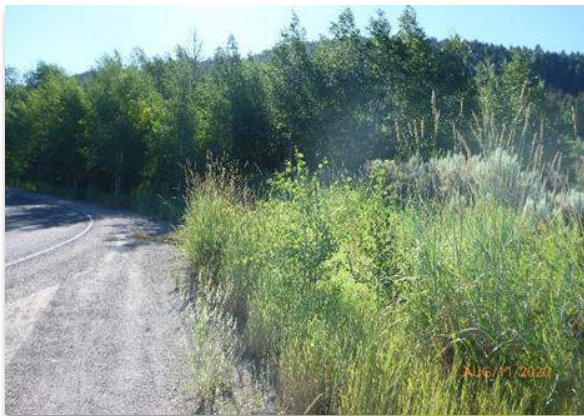
Figure 14. Flat areas can be mowed back 10 feet.

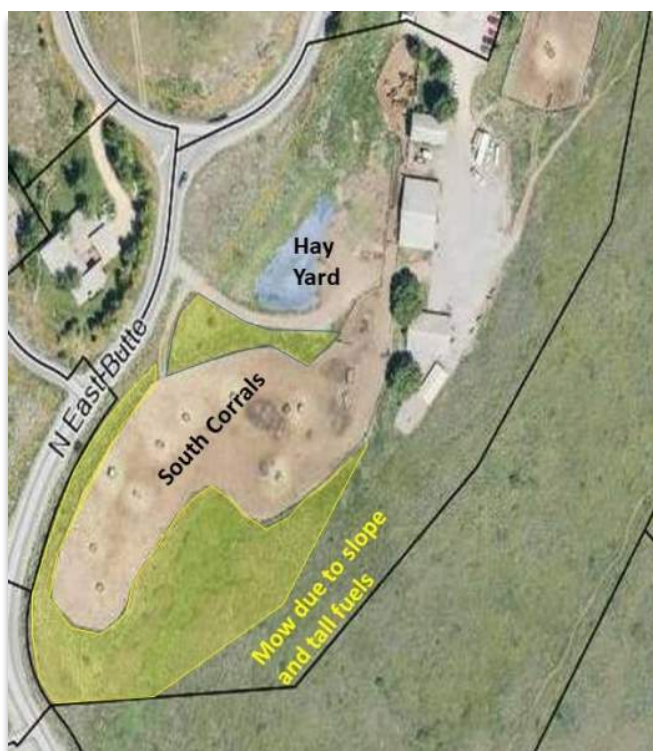
Figure 16. Vegetation maintenance for the south corral.

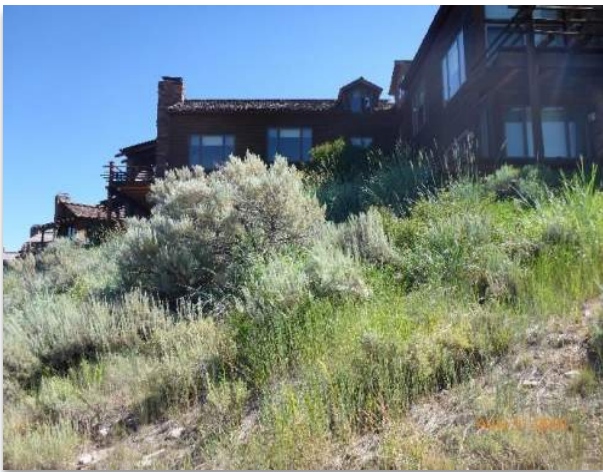
Figure 17. Sagebrush between greenstrip 1 and homes.

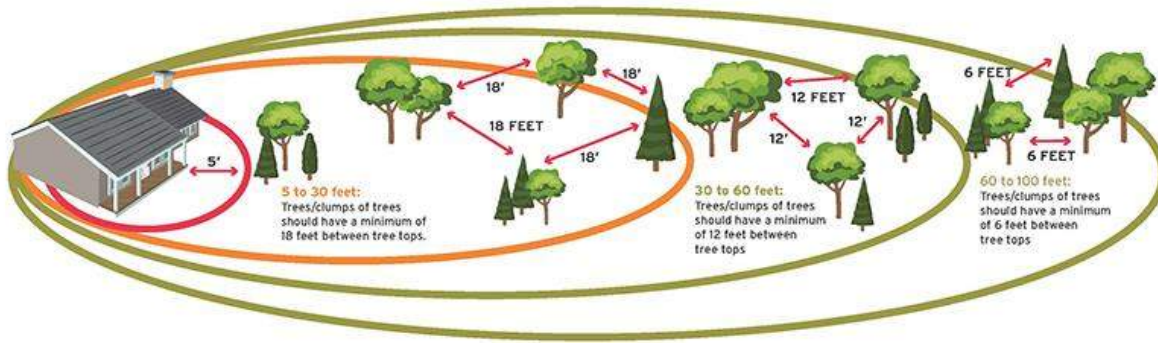
Figure 18. NFPA recommended tree spacing.

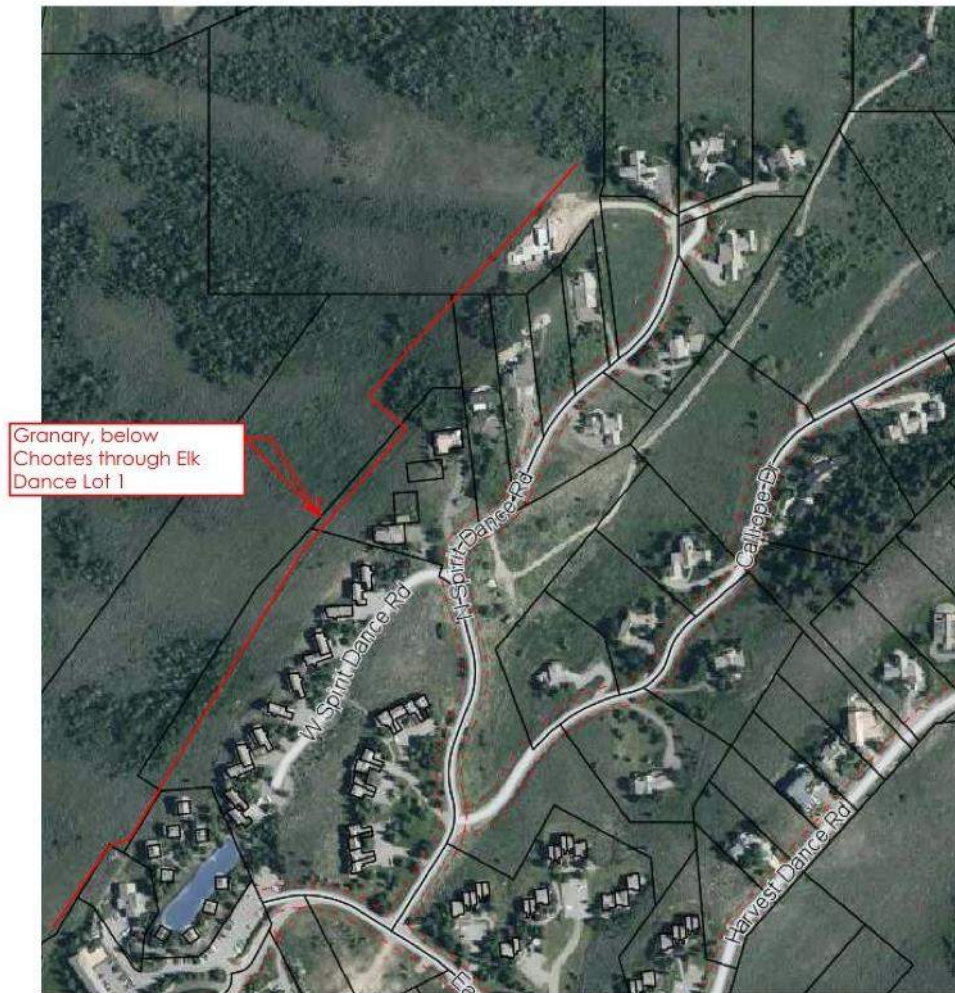
Figure 21. Greenstrip 1 B on the northern end of the property.

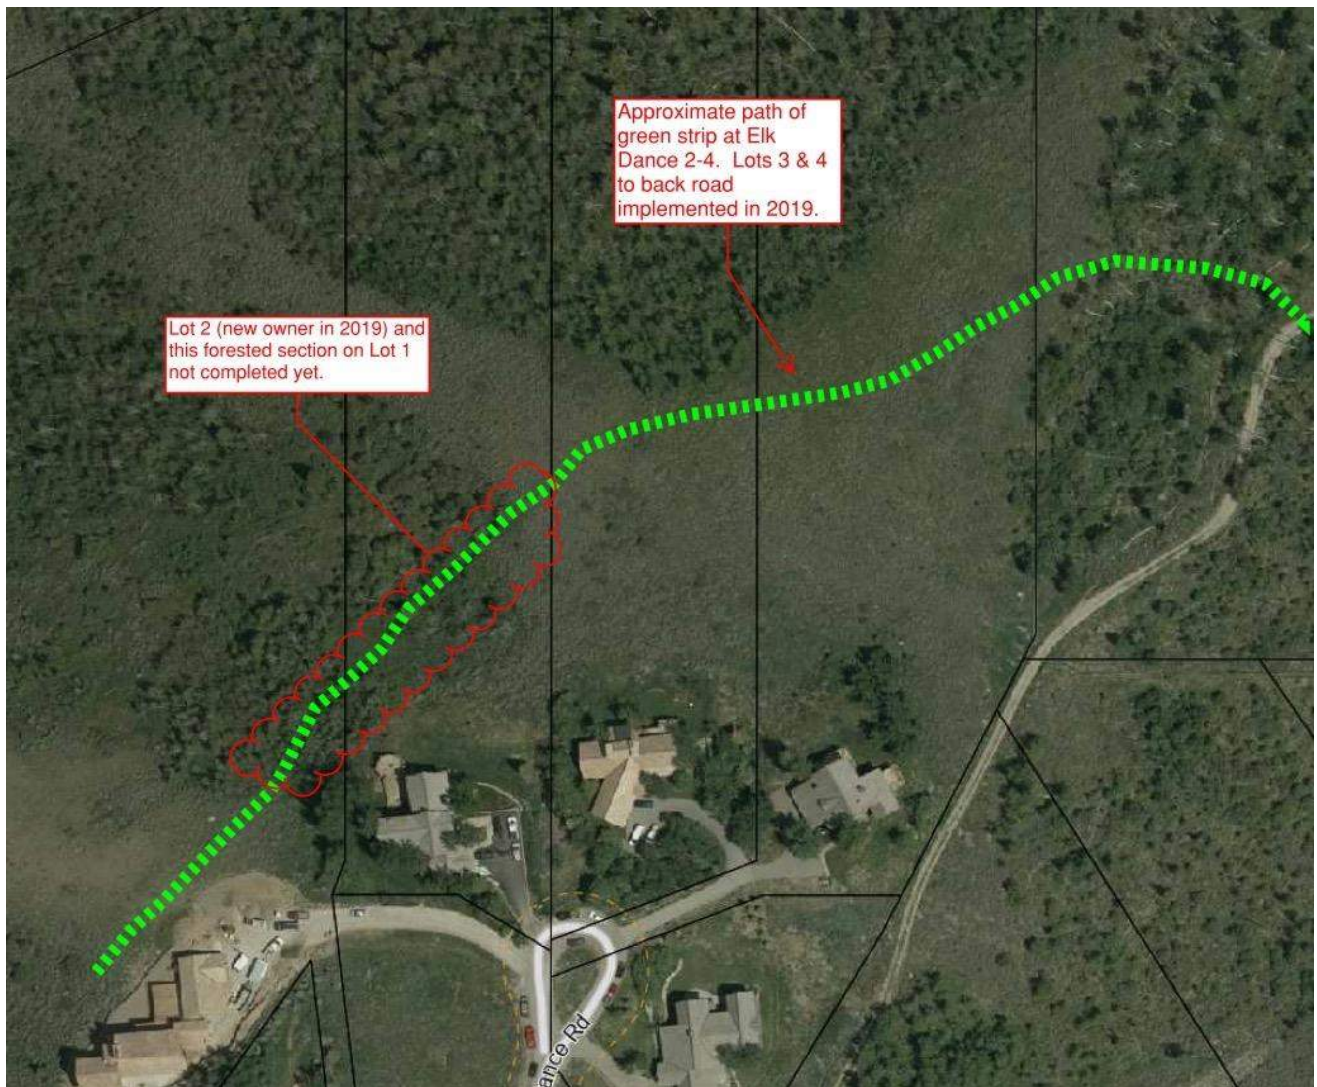
Figure 22. Greenstrip 1B where it connects to greenstrip 2.
